Product Name: **BOV Kompact EM F150**  
 Product Description: BOV Kompact EM F150  
 Product Number: TS-0225-1001  
 Document Version: V1.00 Rev A

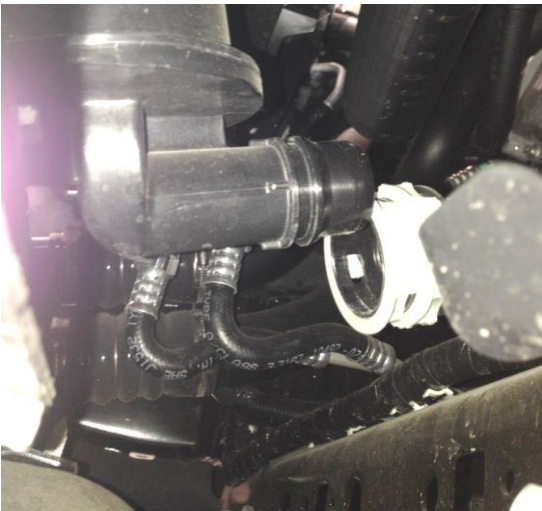
1. Remove the under-tray of the vehicle by removing all of the plastic clips holding the tray in place. Once the under-tray is removed, the intercooler assembly can be accessed. Unplug the OEM BOV plug. Undo the bolts securing the cross member in order to remove the intercooler from the vehicle.
2. Unplug the BOV chamber from the OEM plumb back hose. Install the supplied plumb back hose blanking plug by pressing it into the plumb back hose plug. Please note that the blanking plug will only fit the plumb back hose in one way.

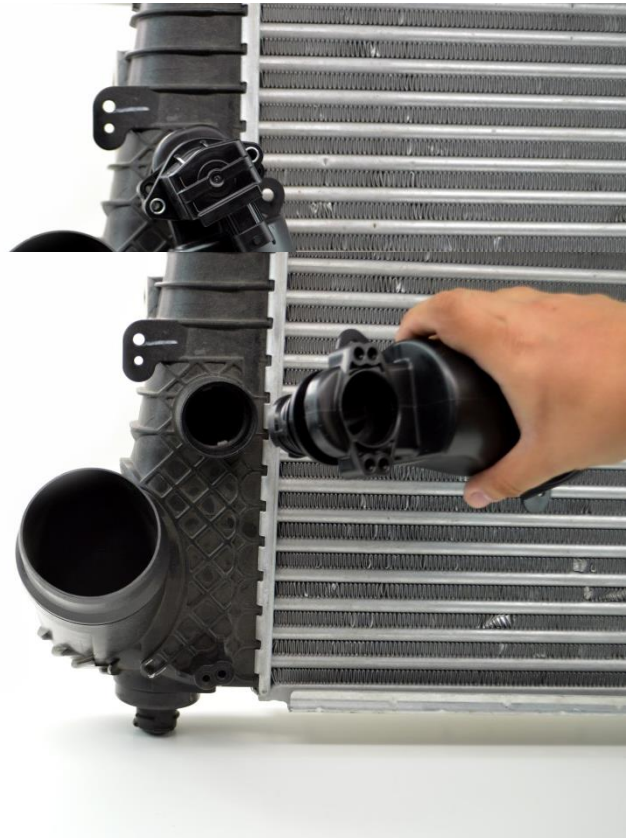
3. Once the intercooler assembly is removed from the vehicle, the OEM BOV can be upgraded. Remove the OEM BOV by undoing the two bolts holding it onto the BOV chamber.
